RESTORING A LOTUS ELAN OR WHAT TO DO UNTIL THE PSYCHIATRIST ARRIVES!

Instalment 1 - Chassis

Lester Reader

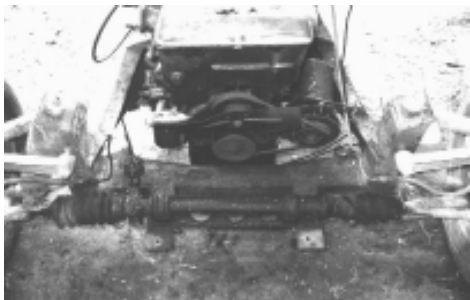
Chassis as it was

A water blaster proved to be just the ticket for getting the muck off the chassis. There was enough gravel in the backbone part of the chassis to re-cover the drive to my garage (or nearly anyway)! Once cleaned and dried I gave it a good going over and decided that the back half was not too bad and wasn't even rusty, the original oxide paint was still sound and the mounting points were all correctly aligned. A few minor modifications to remove, some welding holes to fill and some straightening round the back wishbone anchor points where someone had put a jack in the wrong place.

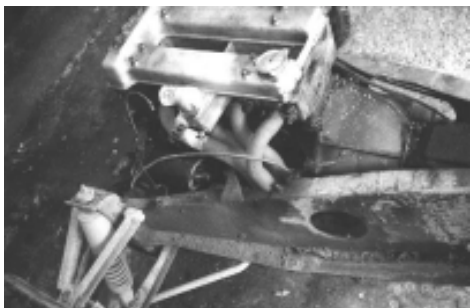
Left Front as it was

The front half was a different matter! As mentioned earlier, both towers were beyond repair, there were several cracks in the side rails of the chassis, the right side was distorted and some idiot had cut a section out to enable the exhaust system to be removed, causing another large crack to develop. I can't imagine what the thing must have been like to drive with the front geometry drastically out of kilter and the chassis about as stiff as spaghetti soaked in tomato sauce!

The left side was a repeat of the right and was less of a problem as there was less damage and distortion to worry about. The chassis side rail cracks were then cleaned up and welded with the aid of John Hill's Mig Welder and these were reinforced with a number of beads of weld stitched across each crack at strategic points. Finally the whole chassis was checked for alignment and dimensions and found to be less than 1.0mm out at any point and the castor angle correct within 15 minutes of arc – probably better than new!

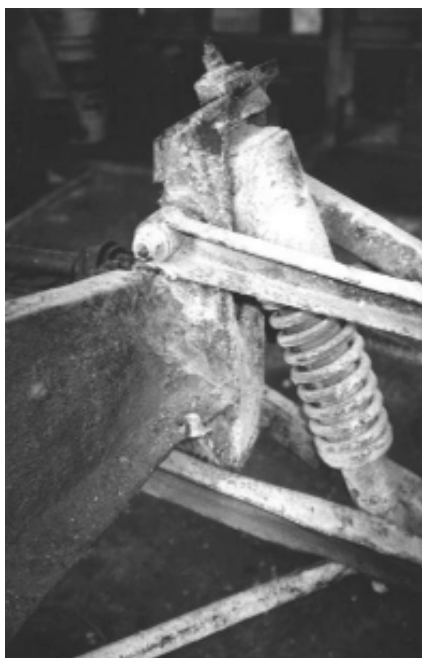
Right front as it was

I then removed the right (damaged) tower from the side rail and cross member and tidied up the rail and the end of the cross member which were to remain. I had decided that the top section of the tower which holds the wishbone pivots and spring/damper attachment was ok so I cut off the bottom three quarters and set about fabricating a new tower round the remains of the old. This was made of 2mm mild steel sheet (slightly heavier than the original 1.8mm ms sheet). I found gas welding the easiest for this

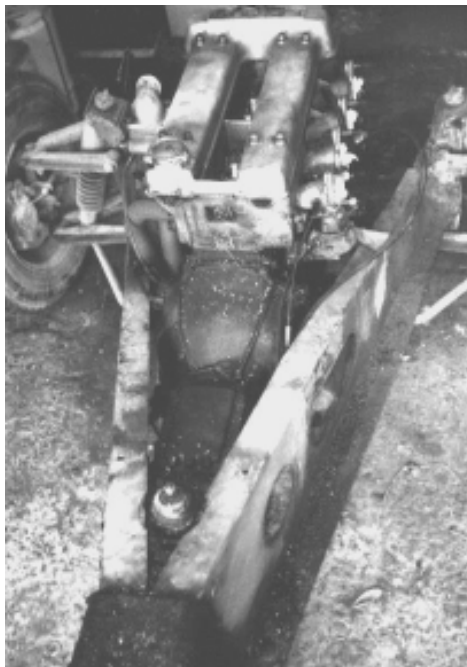
Engine Bay as it was

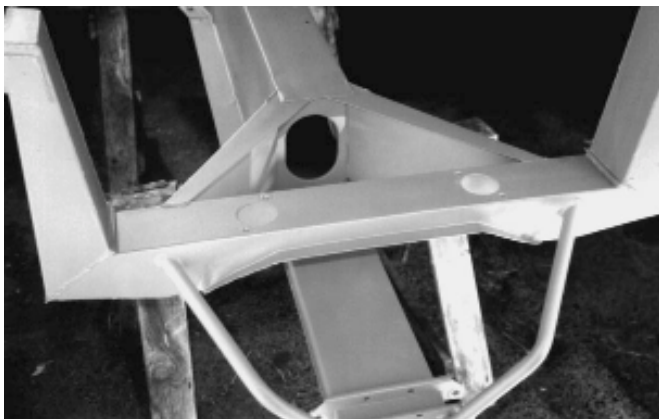
Right front finished

job and it finished up very strong and quite professional looking. Next we set up the new tower in the jig and DC Arc welded it onto the cross member and side rail. One side was now structurally complete and straight.

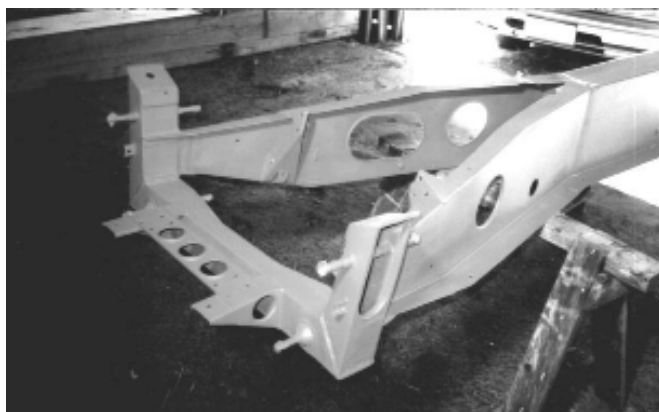
Front of chassis finished

All that remained was to clean it all over with wire buff, disc sander and hand rubbing before applying the recommended POR15 treatment brushed on and followed by a sprayed coat of POR 'Tie Coat' to enable finishing with 3 coats of Red Oxide Lacquer.
